Alfa Romeo Giulia Quadrifoglio 2.9L MAXPower PRO ECM Installation Manual

MAXPower PRO
Engine Control Module

Alfa Romeo Giulia Quadrifoglio 2.9L MAXPower ECM Installation

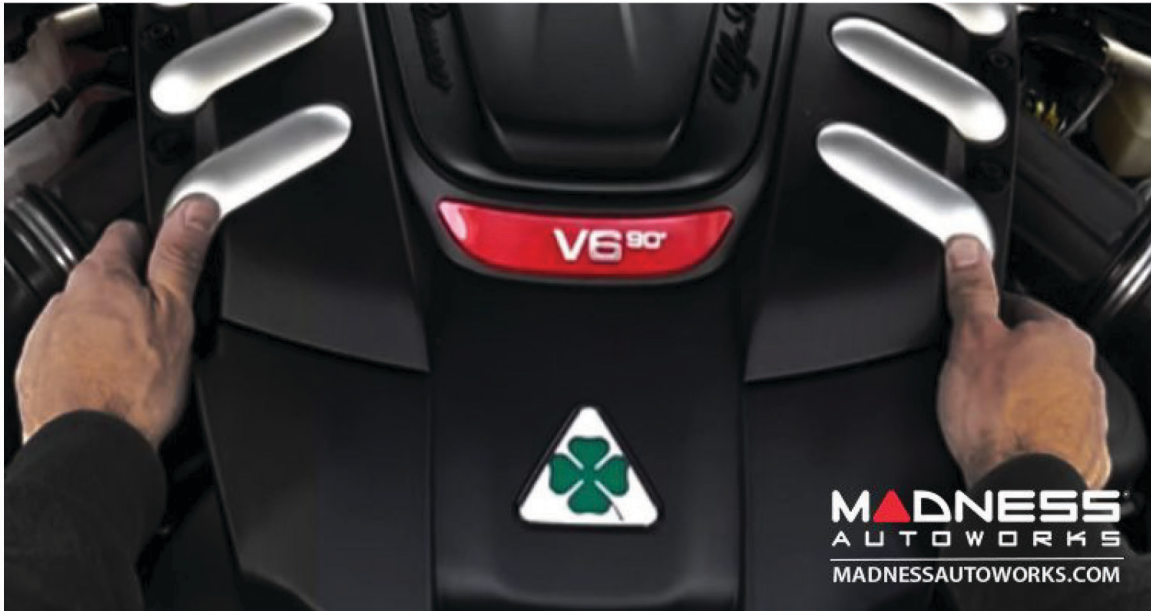
Engine Cover Removal:

1. Gently pull up on the corners of the engine cover to remove the engine cover from the engine bay.

1. Recheck all connections, fittings and fasteners for a properly secure installation.
2. Re-install the engine cover prior to starting the vehicle. The bolt on the left side of the engine cover goes all the way through the valve cover. If you run the vehicle or drive it with the engine cover off, it will mist oil through the engine bay.
3. With the Bypass Plug installed on the harness, turn the vehicle on and check if there are no CEL's (Check Engine Light).
4. Turn the vehicle off, remove the bypass plug and install the **MAXPower PRO**.

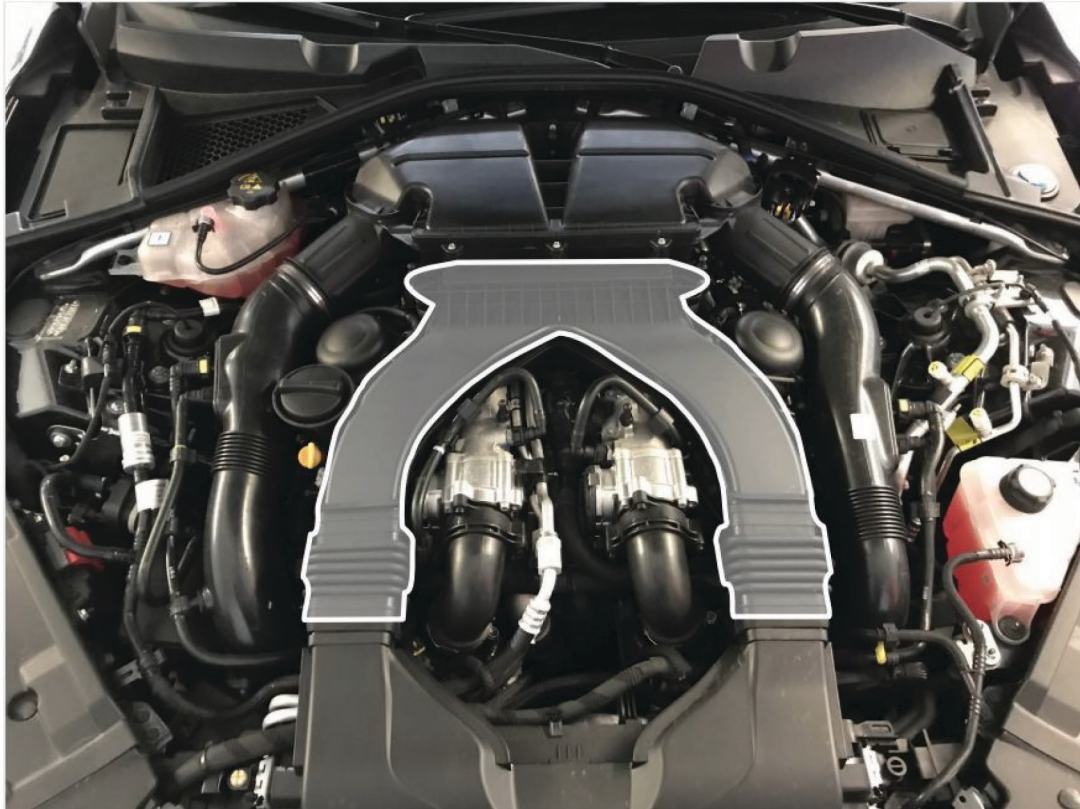
Air Ducting Removal:

In order to gain access to the two Manifold Air Pressure Sensors, the air ducting (see image below) needs to be removed.

1. The air duct is clipped. Release the clips and remove the air ducting from the engine bay.

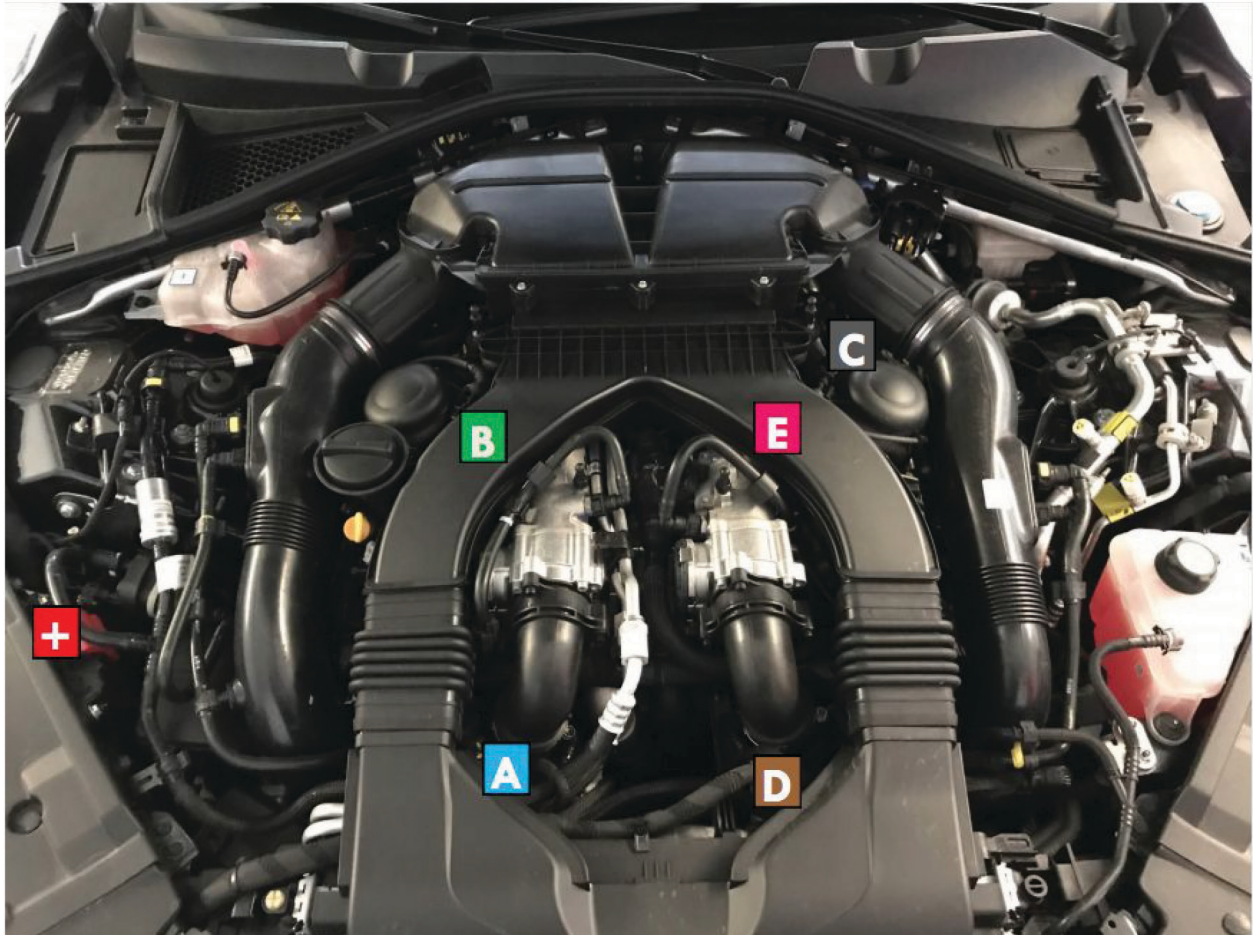
Sensor Connections Overview:

The image above shows the location of the sensors the **MAXPower PRO** taps into.

The colors and letters on the image correspond to the markings on the **MAXPower PRO** Wiring Harness.

- A. Boost Pressure Sensor # 1
- B. Manifold Air Pressure Sensor #1
- C. Camshaft Sensor
- D. Boost Pressure Sensor #2
- E. Manifold Air Pressure Sensor #2
- + . Power Supply

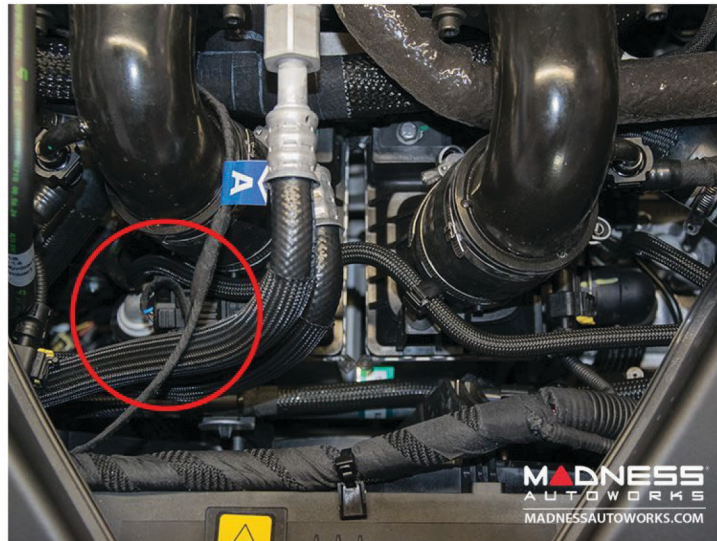
A. Boost Pressure Sensor Connection #1:

The Boost Pressure Sensor #1 is located near the front of the engine bay. See the image below to see the exact location.

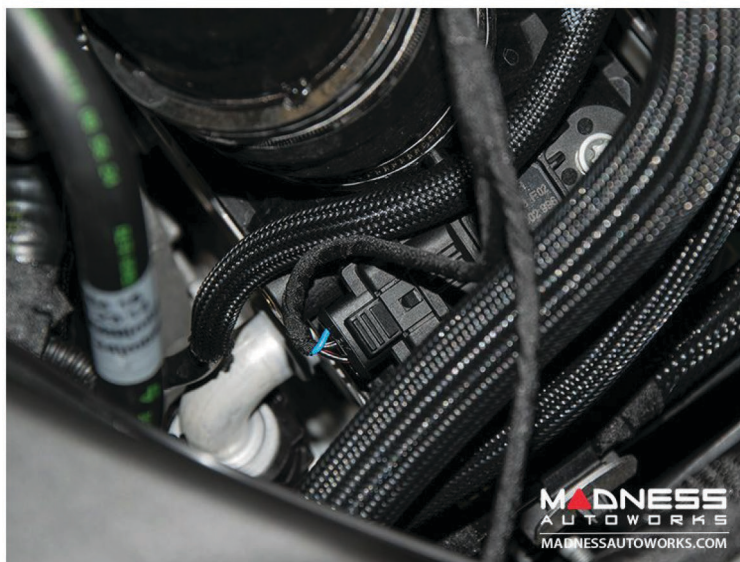
1. Disconnect the factory Boost Pressure Sensor from the factory harness.
2. Connect the **MAXPower PRO** Boost Pressure Sensor in between the factory Boost Pressure Sensor and the factory harness.

NOTE: If you have an Alfa Romeo Giulia/ Stelvio and get a warning light on the cluster that states "Service Throttle Control" you most likely have plugged in the Boost Pressure Sensor upside down. See the photo below of the INCORRECT orientation that caused the problem. **REF E.**

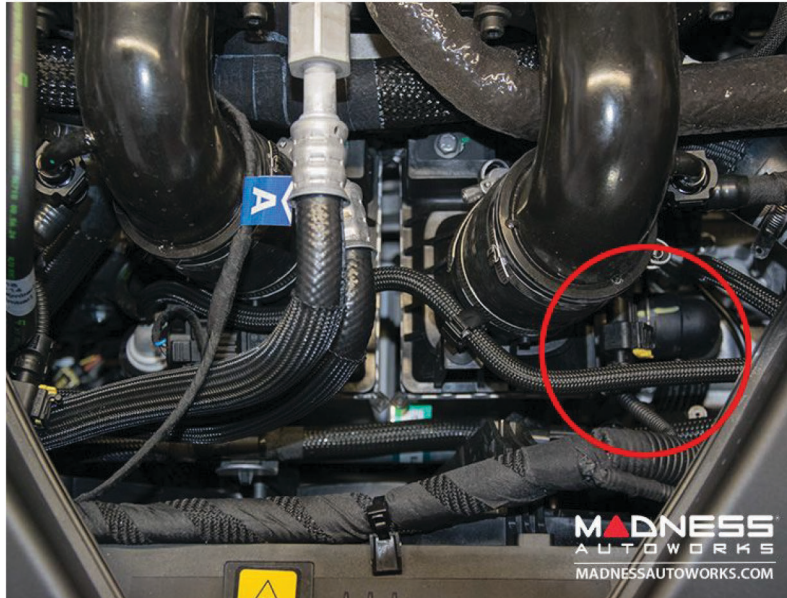
D. Boost Pressure Sensor Connection #2:

The Boost Pressure Sensor #2 is located near the front of the engine bay. See the image below to see the exact location.

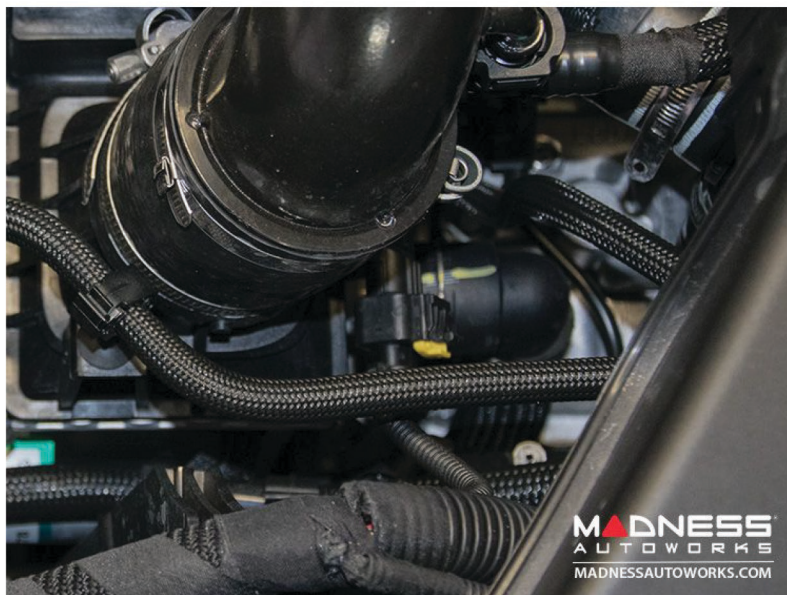
1. Disconnect the factory Boost Pressure Sensor from the factory harness.
2. Connect the **MAXPower PRO** Boost Pressure Sensor in between the factory Boost Pressure Sensor and the factory harness.

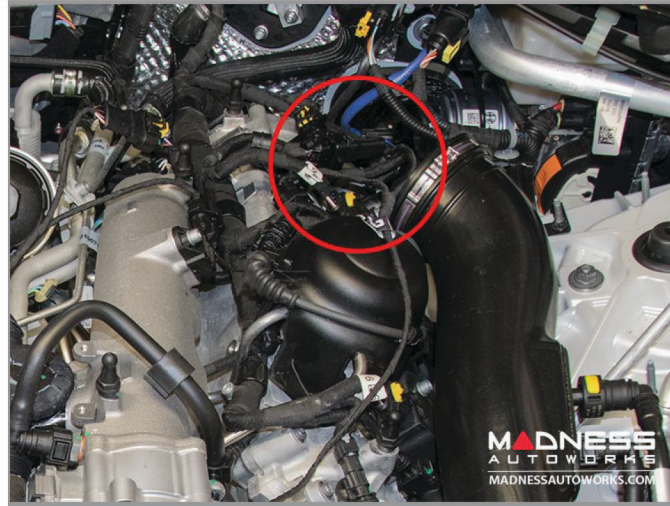
C. Camshaft Sensor Connection:

The Camshaft Sensor is located near the rear of the engine bay. See the image below to see the exact location.

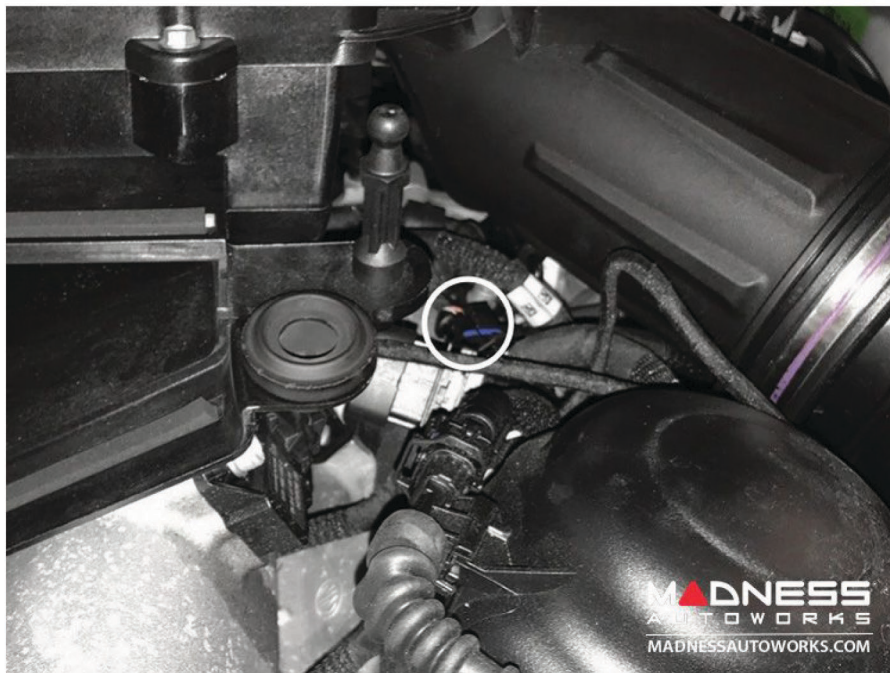
3. Disconnect the factory Camshaft Sensor from the factory harness.
4. Connect the **MAXPower PRO** Camshaft Sensor in between the factory Camshaft Sensor and the factory harness.

The ground comes from the camshaft plug on all harnesses. If you test the black wire at the main connector of your MAXPower Pro and have no ground signal you most likely have an issue with the camshaft plug connection, please check the orientation of this connector.

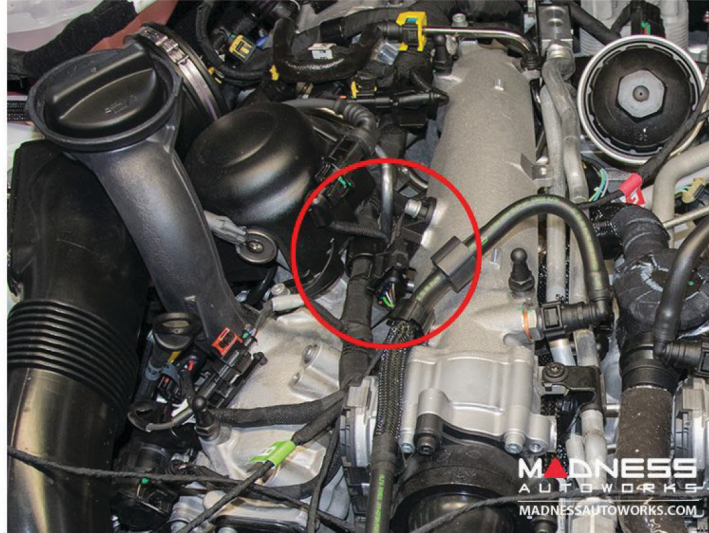
B. Manifold Pressure Sensor Connection #1:

The Manifold Pressure Sensor is located near the center of the engine bay. See the image below to see the exact location.

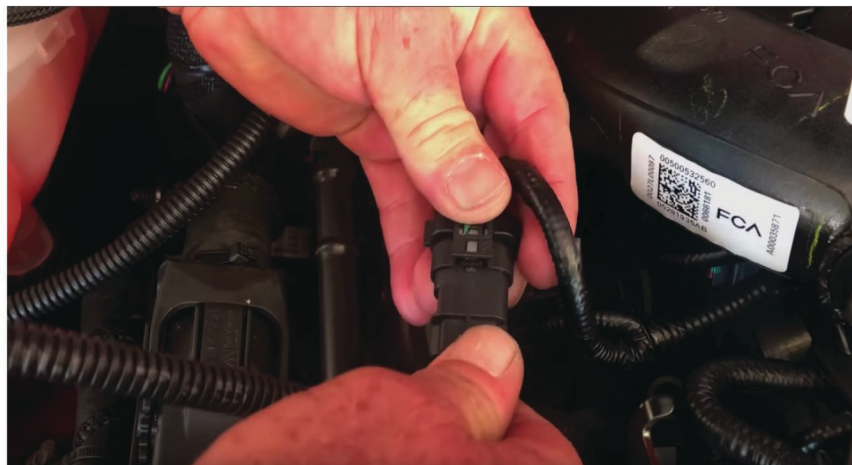
Disconnect the factory Manifold Pressure Sensor from the factory harness.

Connect the **MAXPower PRO** Manifold Pressure Sensor in between the factory Manifold Pressure Sensor and the factory harness.

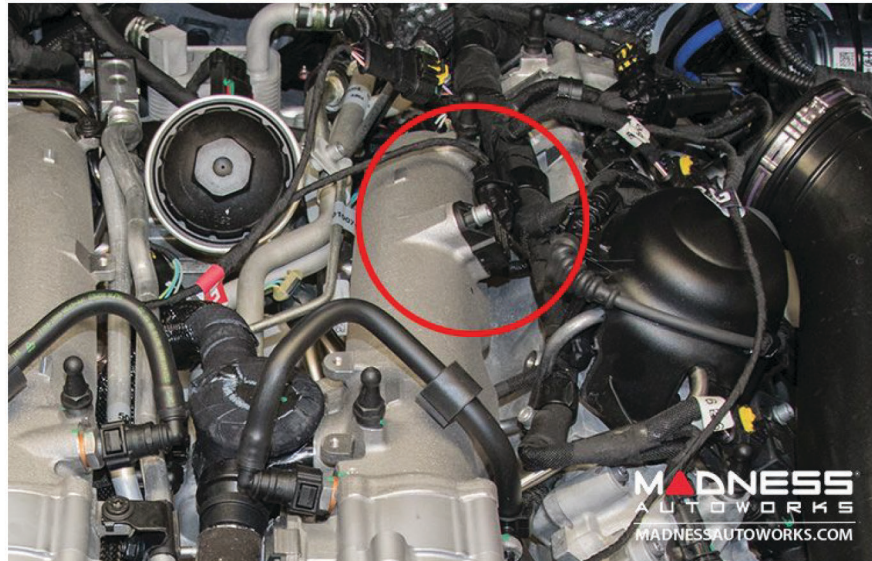
E. Manifold Pressure Sensor Connection #2:

The Manifold Pressure Sensor is located near the center of the engine bay. See the image below to see the exact location.

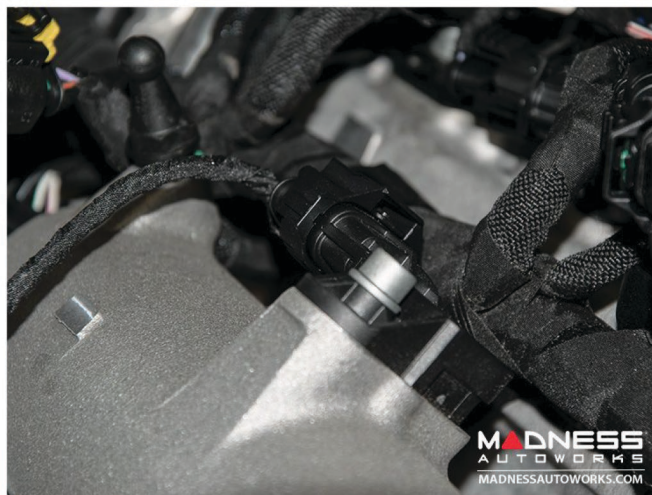
1. Disconnect the factory Manifold Pressure Sensor from the factory harness.
2. Connect the **MAXPower PRO** Manifold Pressure Sensor in between the factory Manifold Pressure Sensor and the factory harness.

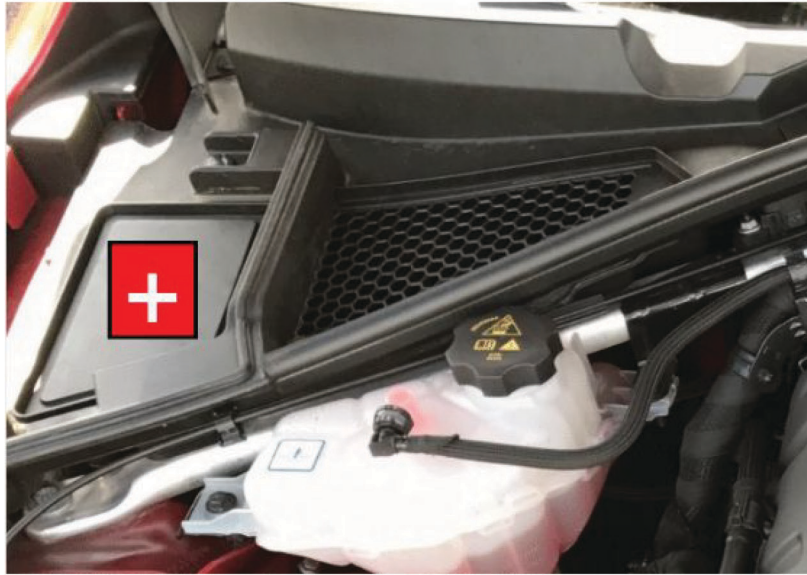
+ Power Supply Connections:

Remove the fuse box cover near the rear left side of your engine bay.

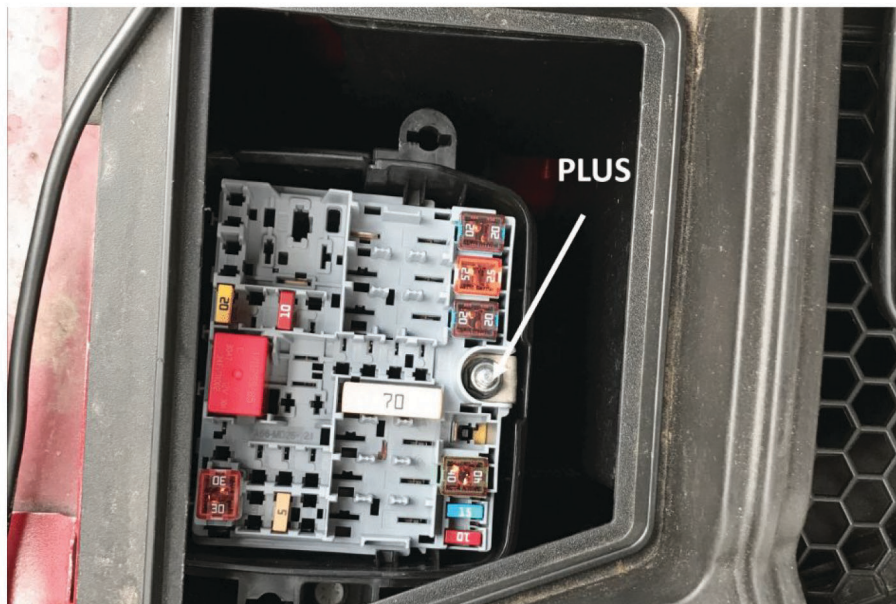
Connect the supplied 12-volt power connections. The positive (red) connection will go on the nut on the fuse box.

1. Loosen the 10mm nut that is on the the fuse box.
2. Connect the positive (red) connection to bolt and tighten the nut.

The red 12v cable at the main connector must have a permanent 12v source, **(IT CANNOT HAVE A SWITCHED 12V SOURCE)**. The best place to connect this is direct to the battery + terminal or power distribution block located under the hood of most vehicles that have trunk-mounted batteries.

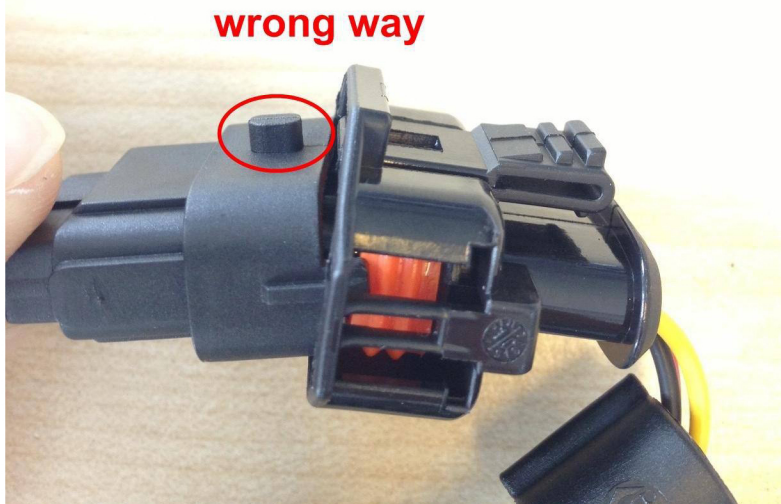
REF A.

Please note that most of the time the cause of a Check Engine Light (CEL) or drivability problem can be traced back to a faulty harness connection or a connection that is plugged in upside down. **REF A.**

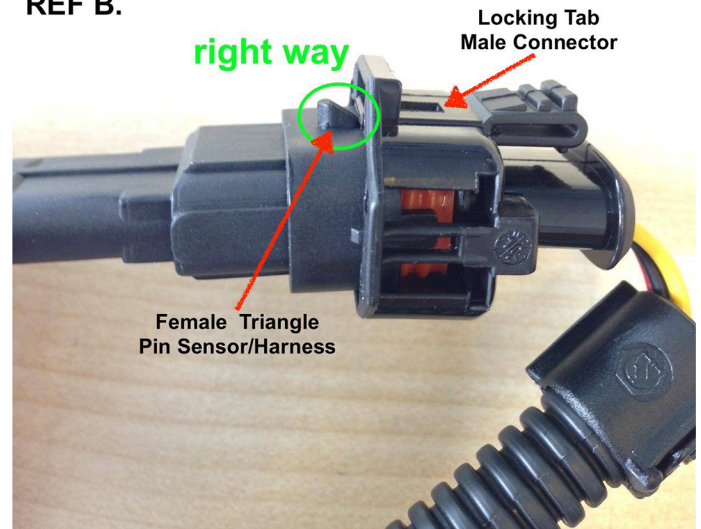
REF B.

If you are running into these issues we ask that you check the connection integrity and verify that all connections are seated and plugged in the correct orientation. **REF B.**

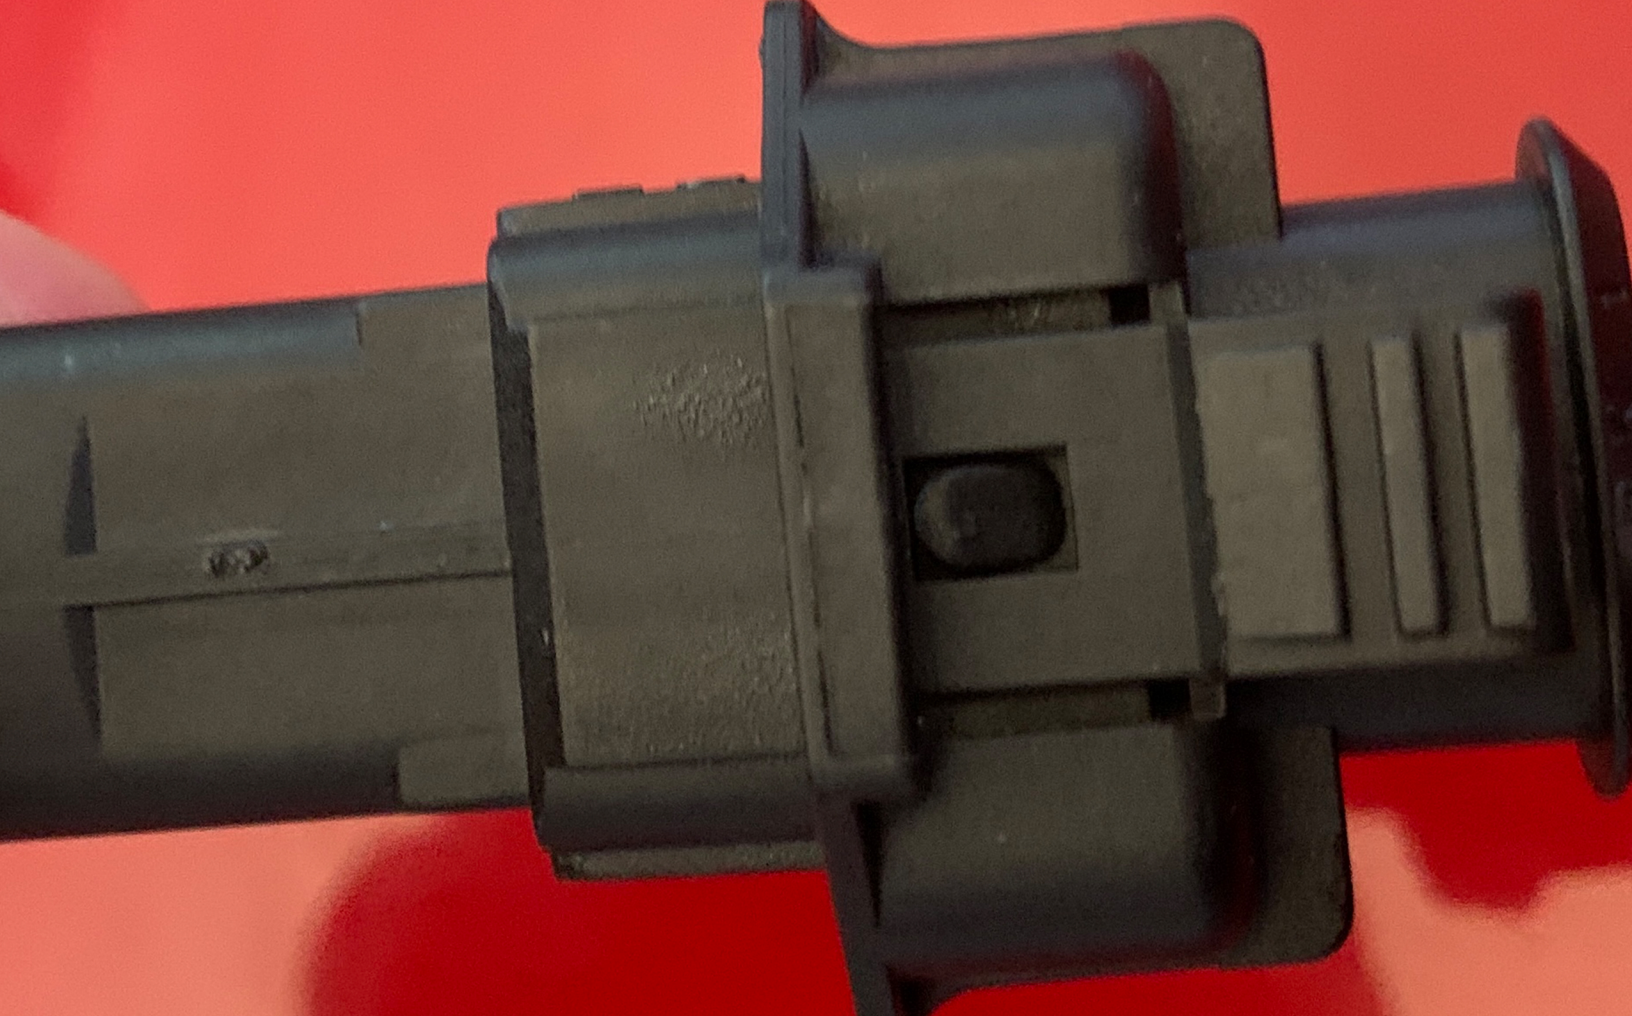
A connection is fully seated when the locking tab on the male connector clicks over the female triangle pin on the sensor/harness connection.

See the photo below.

- Make sure all connections are in the correct orientation with the sloped locking pin on the female connection/ sensor corresponding to the locking tab on male connection.

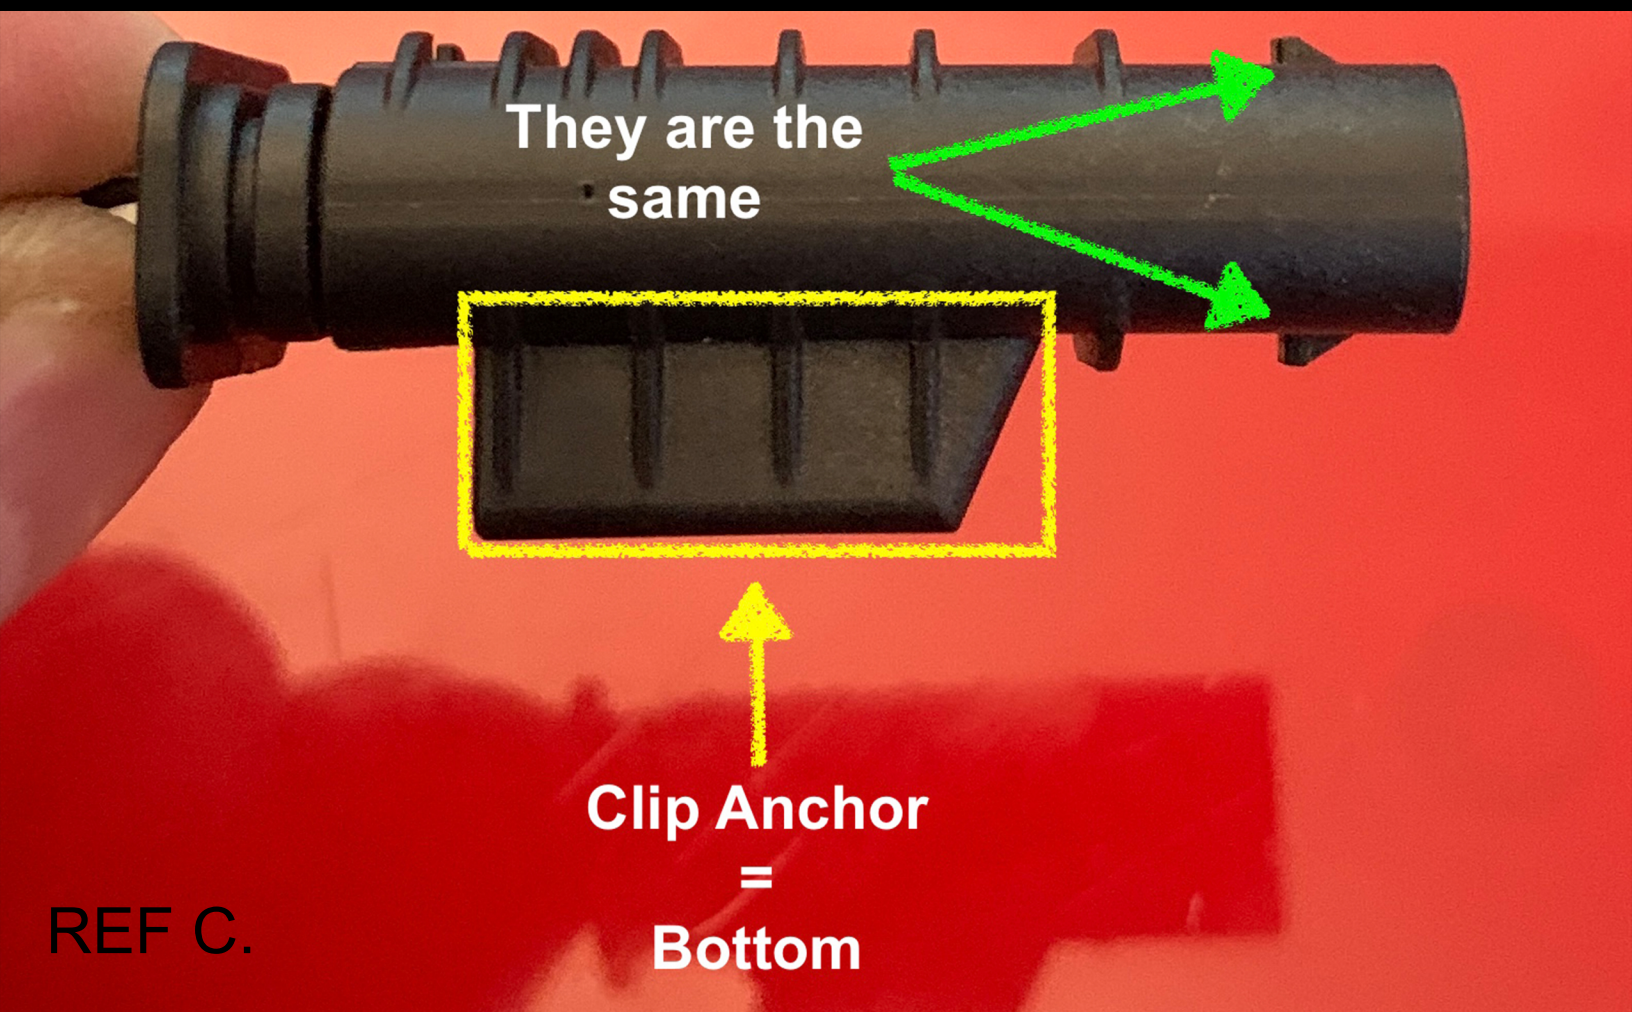
NOTE: On some applications, the "pin" is shaped the same on both sides. REF C.

They are the same

Clip Anchor
=
Bottom

In those cases, you must determine the correct orientation of the connection. As a general rule, the clip anchor that is molded into the female connections always denotes the bottom connection. **REF C.**

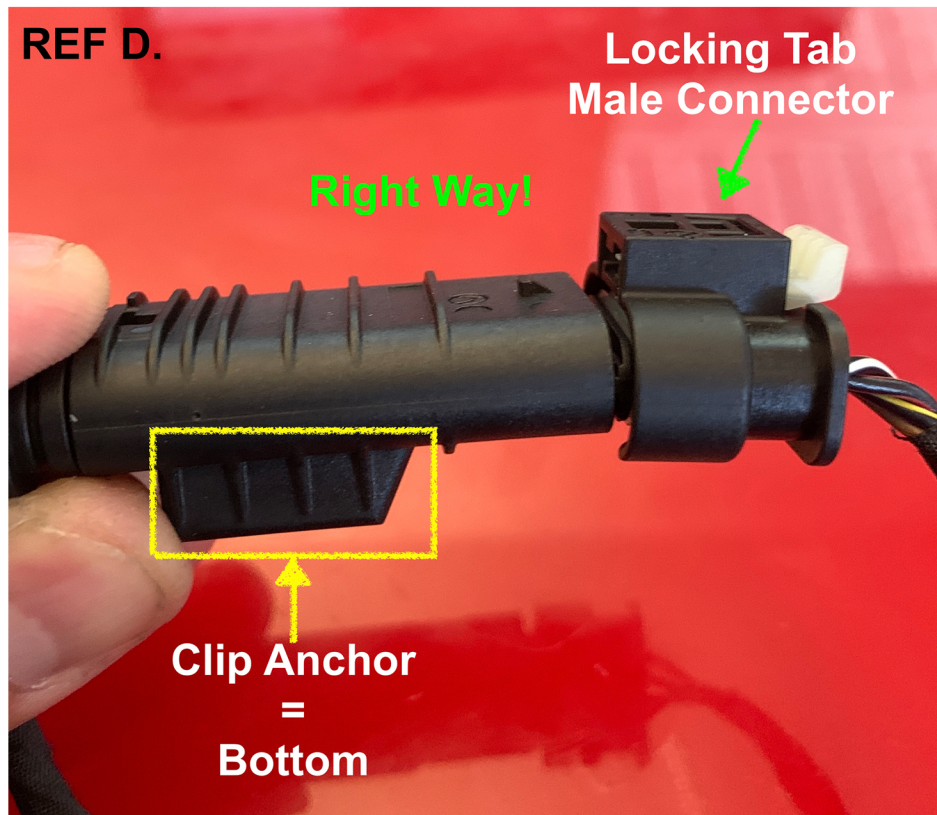
Below is an example of the CORRECT orientation. **REF D.**

To fix this issue plug the connection in so it looks like **REF D.**
